# HEALTH & SAFETY ALERT

## Defective Double Couplers

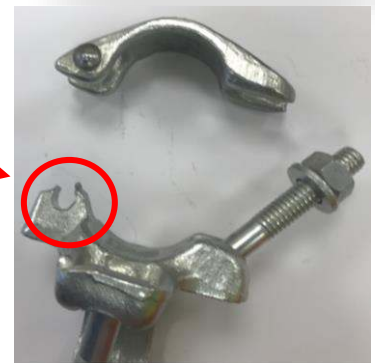
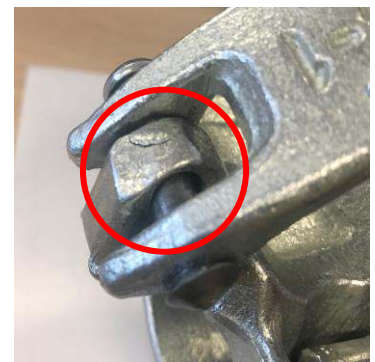
When erecting a handrail using tube and fitting, a drop forged double coupler failed when tightened. The coupler was immediately replaced, quarantined and reported by the vigilant member of our scaffold team. On initial inspection the coupler had sheared at the gate hinge pin lug.

Further inspections took place on random couplers contained in the recent batch delivered to site and it was identified that a number of similar and additional defects were present, including:

- Incorrectly positioned lug holes
- Incorrectly tapped nut threads
- Incorrectly dyed bolts threads
- Missing and bent washers

The couplers were supplied by **Altrad Beaver84** and manufactured in China. Markings on the couplers seem to be correct stating **EN74-1 Class BL**. An investigation has been instigated by both KBJV and the Supplier.

- Quarantine all tube and clip scaffold pending visual inspection.
- Upon visual inspection remove and replace all double couplers with batch number **BM0218G**
- Re-inspect the scaffold and confirm with the scaffold Foreman.
